Water Contamination Caused by Gasoline Permeating a Polybutylene Pipe

William G. Leseman

A water quality complaint received by the city of Tallahassee, Fla., resulted in an investigation that found contamination of a service line caused by gasoline leaking into the soil surrounding the pipe. The service connection to an apartment was the only incidence of the contamination, but levels of 1,2-dibromoethane were found in one apartment to be 50 times the limit set by the Florida Department of Environmental Regulations. The service line was replaced with copper pipe, which solved the problem.

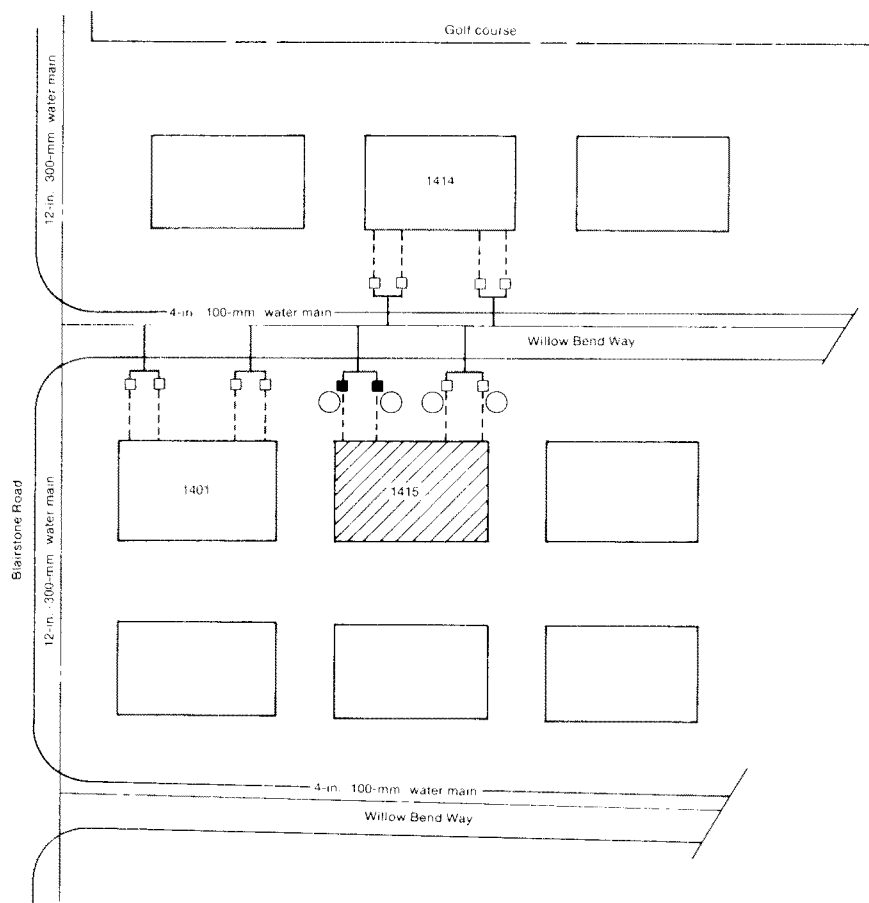
Figure 1. Location of the affected service connection

The complaint about the taste and odor of tap water was received Sept. 18, 1984. The customer lived in an apartment complex consisting of separate units with four apartments per unit. The building was less than five years old and was located adjacent to a public golf course in a highly developed middle-class area (Figure 1).

Maintenance records for the distribution system in the complaint area were reviewed, and nothing unusual was noted. The service connection for the apartments at 1415 Willow Bend Way had had a leak in June 1983, which had been repaired. It was also noted in the records that the $\frac{3}{4}$ -in. (20-mm) service connections in that area were constructed of PB pipe. No leaks for this service connection had been reported in previous years, and interviews with the apartment management concluded that no internal problems had occurred.

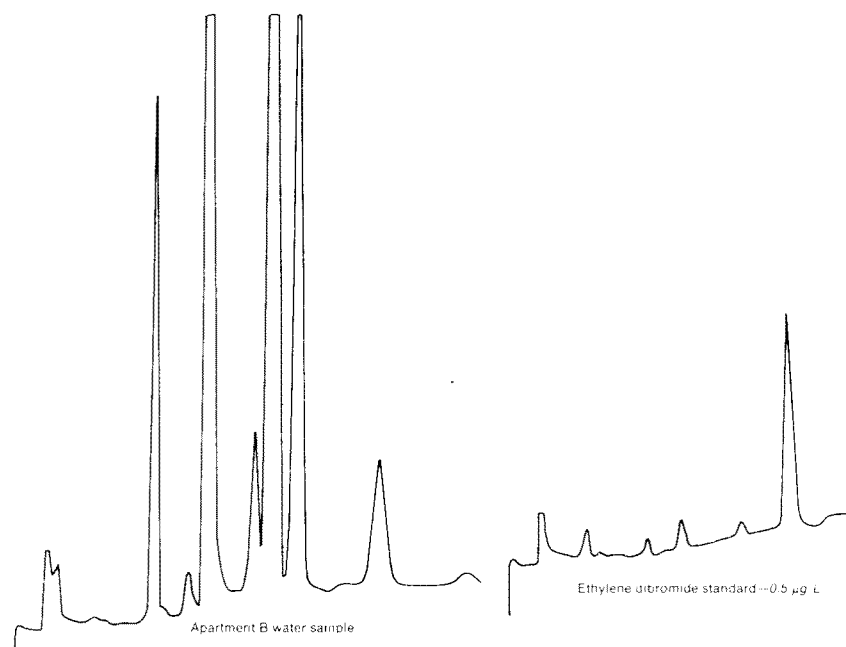
Figure 2. Chromatogram of sample from 1415 Willow Bend Way, apartment B

A water well operator trained in sampling techniques was dispatched to the apartment to evaluate the complaint. He noted that the water did indeed smell like paint thinner and that the odor was persistent. A 40-mL sample from 1415 Willow Bend Way, apartment B, the location of the complaint, was collected using a vial lined with PTFE septa. The sample was analyzed using a purge-and-trap concentration with GC analysis. External standards were used for qualitative as well as quantitative confirmation.

Surprisingly, the initial sample showed the presence of EDB at a concentration

of 1.02 $\mu\text{g/L}$, 50 times the FDER limit of 0.02 $\mu\text{g/L}$. This finding was unexpected and somewhat discounted; however, the presence of EDB was confirmed by using a second column and comparing retention times to an external standard. A second sample was collected to eliminate the possibility of contamination of the sample bottle, and it showed a concentration of 0.85 $\mu\text{g EDB/L}$ (Figure 2). The customer, who had been using bottled water since first noticing the odor, was contacted and instructed not to drink the water while a sampling survey was conducted on the distribution system in the immediate area. Four samples were collected from within 0.5 mi (0.8 km) of the location of the complaint. All four samples were negative for EDB contamination. This survey eliminated the possibility of widespread contamination of the distribution system.

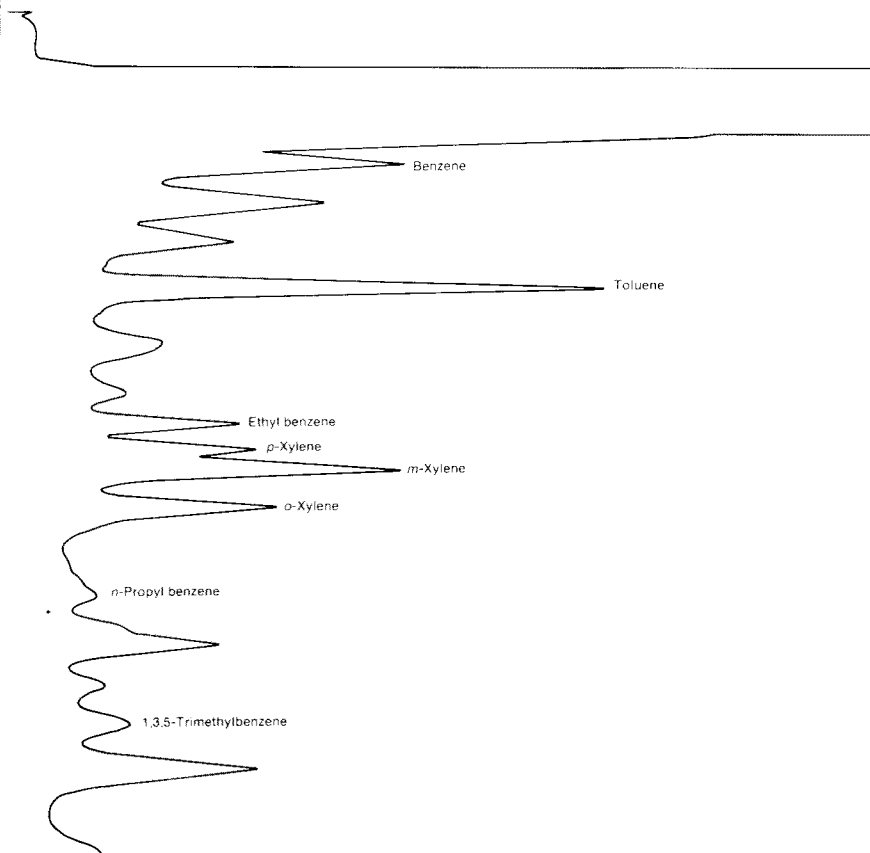
Figure 3. Aromatic hydrocarbon analysis of contaminated soil

The location of contaminated soil under a parking lot, along with the physical properties of the pavement overlying the soil, provided evidence that the contamination was probably caused by gasoline spilled on the surface. In order to confirm this theory, the soil was analyzed for aromatic and alkyl aromatic hydrocarbons and EDB, and an acetone extract of the soil was analyzed using capillary GC-MS.

Alkyl aromatic hydrocarbons were analyzed using purge and trap with GC-flame ionization detection (FID). External standards were used for qualitative analysis. Figure 3 shows the packed column chromatogram of the soil. The presence of benzene, toluene, ethyl benzene, and xylenes provided evidence of a fuel spill.

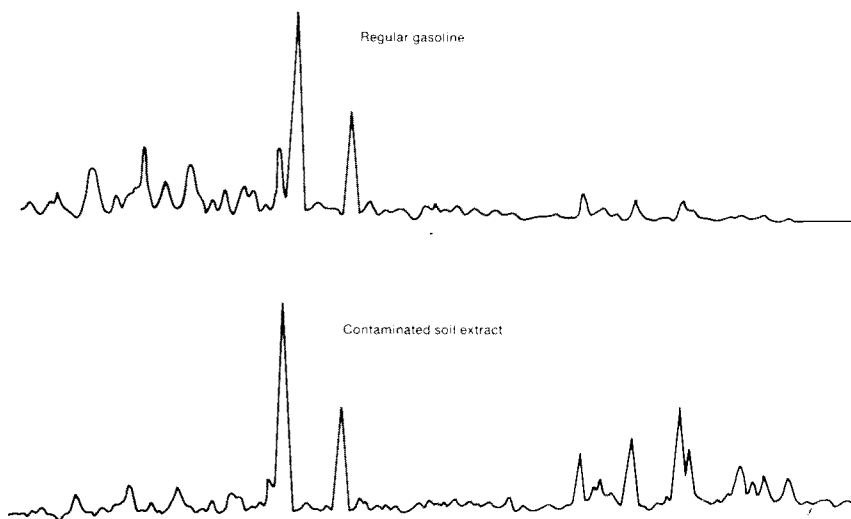
Figure 4. Chromatogram of regular gasoline and acetone extract of contaminated soil

A GC with a capillary column interfaced with an MS was used to analyze acetone extracts of the contaminated soil. Retention times and mass spectrum peaks observed in the soil extract were compared with peaks obtained from a sample of regular gasoline, thus confirming that the soil was contaminated with leaded gasoline. Determining the individual compounds in the gasoline by comparison with known standards was not required, and the method provided adequate proof that the source of contamination was regular gasoline. Figure 4 shows a comparison of peak retention times in the range of 14–18 min for regular gasoline and the soil sample with mass spectrum of the peaks plotted for each peak.

The solution to such a problem is the immediate replacement of the contaminated pipe and removal and replacement of the contaminated soil. The customer's lines should be flushed and samples collected to ensure that there is no residual organic contamination left in the lines.
